Remap Newsletter No.95 – September 2022

Derby, Burton & District Panel
Serving Derbyshire & East Staffordshire

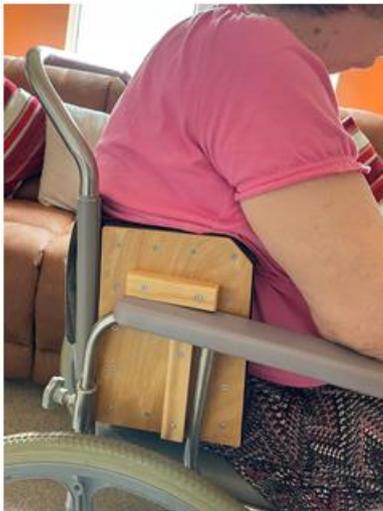
DB-22-007 – Allan Sutton

A lady had difficulty staying upright when seated in her wheel chair and her feet slipped off the footrests. The wheelchair belongs to Mediquip so no holes or permanent changes were permitted.

The solution to keep her more upright was to provide two covered foam pads. The pads just rest in place so she can remove them when

entering/leaving the chair. To keep her feet on the footrests, extension plates have been made that clamp on the existing plates. They have a rear stop to help keep her feet in place. The pads had a plywood backing and the footrests were made from kitchen cutting boards that were source of suitable plastic sheet. The pads are clamped to the footrests using countersunk bolts into tapped aluminium bars. The footrests fold as normal.

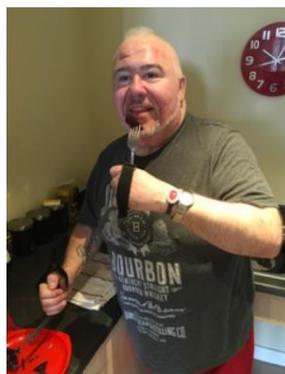
DB-22-021 – Steve McCordick

The client has very little strength in his hands and wants to be able to cut food at meal times. A Victorinox tomato knife was modified and fitted to a holder. Once it was strapped to the client's hand he can now cut steak and other foods. A fork holder was then made and the client can now eat meals without assistance.

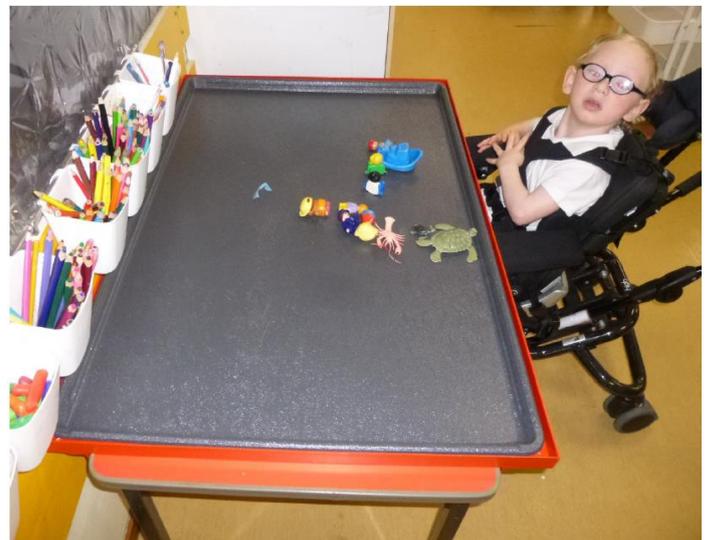
DB-22-030 – Mike Banks

A wheelchair bound child wanted to play with sand in a tray. The school was not able to meet the child's needs and approached REMAP for help.

The school provided a 44ins X 22ins table and it was agreed that a tray assembly could be fitted on top to enable the child to play with sand and water whilst sitting in his wheelchair. The lip on this tray had to be about 30mm high.

A suitable plastic tray was found which is 44ins X 22ins with a lip height of 25mm. A steel frame was made from welded 30mm angle to contain the tray. The frame locates on to the table top by sliding it in from either side and has locating pegs which prevent the tray/frame from being lifted when in place. The steel frame was spray painted red to match the top of the table.

Four wooden blocks were also made to raise the table height. These have rubber bases for stability.

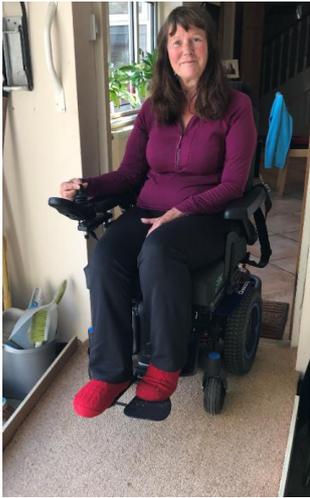
DB-22-033 – Peter Brien

Client has MS, and is beginning to use a powered wheelchair more. She needs ramp access to the house. Both front and back doors have significant access problems with porch / sills, drain pipes in the way, etc.

A door from the kitchen to the garage, with a couple of steps in the garage, had much fewer problems. A recently removed ramp was reused. The steel frame, 14mm plywood deck and side-boards were recovered. A

strip of carpet was fitted. Screwed batten to top step support the upper edge, and the ramp was screwed to the batten to hold it in place

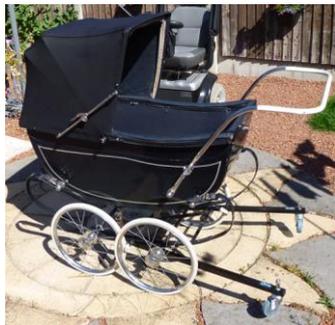
DB-22-046 – Mike Banks

A client is a vintage pram enthusiast but struggles with stability. A mechanism was required to prevent the pram from tipping up when the handle is leant on.

Two rearward projecting steel arms were installed at axle height, one each side, each carrying a castor wheel at its outer end. The arms splayed outwards to give maximum width for foot space and the castor wheels were positioned rearwards to be nearly under the pram handle so resisting

over-tipping of the pram. The castors were positioned clear of the ground and so only operate if the pram begins to tip downwards. There is scope to adjust this ground clearance to best suit the client and she has been briefed on how to do this.

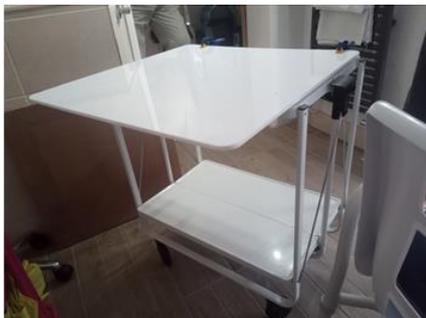
DB-22-032 Bernard Killeen & Dennis King

Client uses a trolley to administer medication but as the trolley has no overhang it is awkward to use. The solution is to fit an additional top to the trolley. The client requires that the top can be adequately sterilised and so a waterproof material is required that will not trap dirt. A sheet of acrylic was chosen such that it can be removed and effectively cleaned / sterilised. The top is located in place using spring clamps.

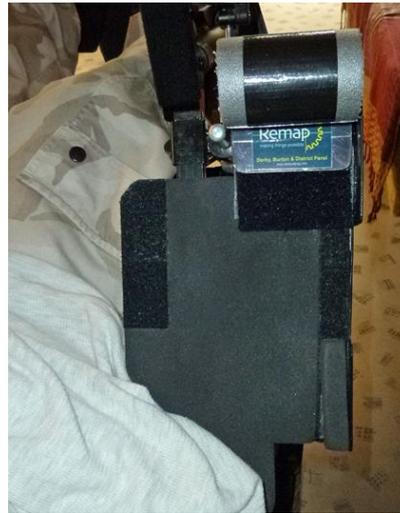
DB-22-050 Mike Banks

A client with significant muscle deterioration spends a substantial amount of time in a wheelchair.

Although the client requested removal of 20 mm from the side of his armrest in the referral, he had reduced this requirement to 5 mm when I visited. He also requested that the front edge of the armrest be modified and a curved

radius introduced. He additionally requested that his “wrist-rest” be replaced by one comprising a cylindrical shape covered in foam. The “wrist-rest” attaches to the arm rest top surface by Velcro tape.

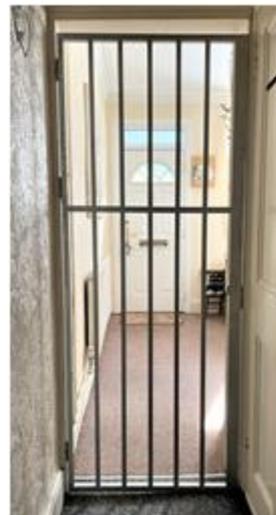
DB-22-061- Allan Sutton

An autistic 7 year old client, was provide with 3 x 1.5m high safety gates in April 2021. One of the gates is in a narrow corridor between two rooms and he has found a way of climbing over it by holding on to the vertical bars and walking his feet up the adjacent wall.

The gate height was increased by simply adding extensions to all the vertical members with appropriate linking members. However, the extra height added some flexibility to the vertical bars, and after a couple of days the boy attempted to squeeze through by pulling them apart and got stuck. His mother needed help to get him out!

The solution was to fit a bracing cross member just over half-way up (below the original top hinge and above the security bolt) to provide extra stiffness. An additional hinge was also added at the top of the extension to improve overall general stiffness. The notched bar locations also gave added lateral strength.
